**Flood Control Project Maintenance  
Levee Inspections**

**Fall 2014 Levee Maintenance Deficiency Summary Report**

**Levee District No. 0001 (Sutter County)**

| Waterway | | | Bank | Unit Miles |
|--|---|---|---|---|
| Unit No. 01 Feather River | | | Right | 16.11 |

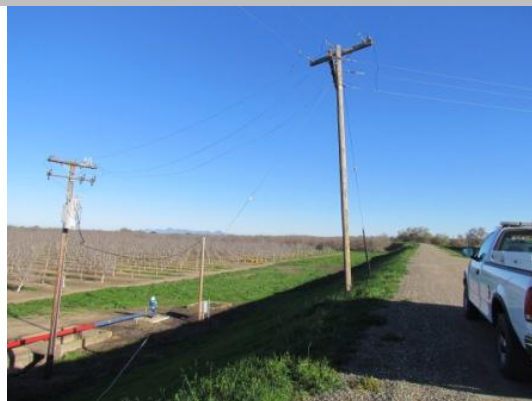
Photo 1 of 1 : FA\_2014\_LD0001S\_433\_8\_20141110\_00001.jpg

| Pole<br>Inspector Comments: Power pole set on landward levee slope. Spring 2014. | | | | | |

This photo was taken from the crown of the levee facing north looking at a power pole set in the landward levee slope. Spring 2014

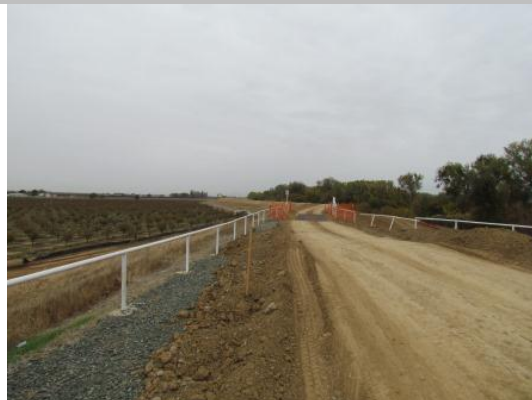
Photo 1 of 1 : FA\_2014\_LD0001S\_433\_14\_20141124\_00012.jpg

| Inspector Comments: I am unable to inspect this section of levee due to the Sutter Buttes Flood Control Agency levee upgrade project. | | | | | |

This photo was taken from the crown facing north looking at the levee update project. I was unable to inspect this section due to ongoing construction. Fall 2014.

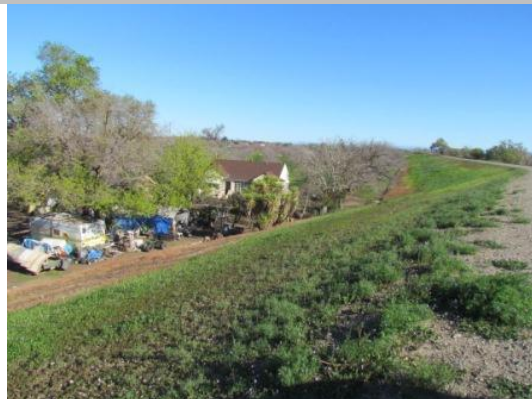
Photo 1 of 1 : FA\_2014\_LD0001S\_433\_489\_20141110\_00005.jpg

| Landscaping<br>Inspector Comments: Landscaping on landward levee slope. Spring 2014. | | | | | |

This photo was taken from the crown of the levee facing north looking at vegetation on the landward slope. Spring 2014.
